Forensic Investigation on Design and Construction Failures

P. B. R. Dissanayake

Abstract: In this study, forensic investigations on several structural failures in Sri Lanka have been investigated. The reasons that led to failures of these selected case studies have been studied. In this context, method of forensic investigation includes structural analysis, Finite Element Modelling and material testing to some extent. With the outcomes of those analyses, real reasons for each failure have been explained. Furthermore, the responsibilities of some of the failures in these cases are highlighted. Finally, general conclusions are drawn from the study.

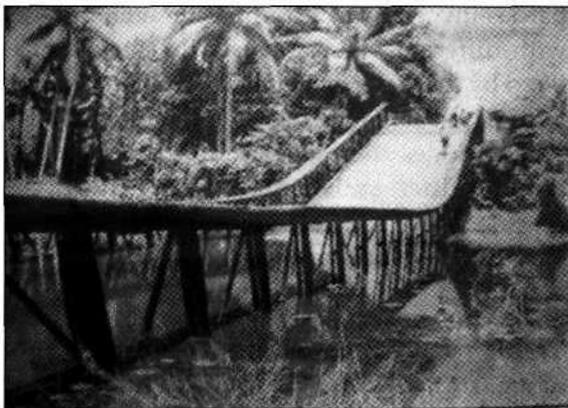
Figure 1: Failed bridge at Paragastota

To understand the failure of the bridge, a Finite Element Model of the bridge was prepared using SAP90 structural analysis software. Truss members were modelled as 3D frame elements. Furthermore, material parameters obtained from laboratory testings were put into the above model. From this structural analysis, it was found that the member force of the bottom chord member at mid-span is exceeding the elastic capacity when the 25 tonne tipper passes over the bridge. In other words, some members are likely to deform plastically when subjected to the above moving load. However, as the load is moving, the high tensile force is present over a small period of time, this preventing the progressive collapse of the structure in the first instance. Nevertheless, this will produce an irrecoverable deformation in the member. This is likely to cause a sag in the truss. With a the similar effect from the other members, forces are likely to change along with some other member forces also exceeding the elastic capacity. From the analysis it is evident that the failure was triggered by the yielding of the bottom chord members, resulting in large deformation, with consequent yielding and fracture of diagonal members [4]. Table 1 shows the summary of the findings.

Member	Applied load due Dead and Imposed loads / (kN)	Elastic capacity / (kN)
Critical bottom chord member (Member No 17)	-1950	1870
Critical diagonal member (Member No 235)	540	600

were and thus the failure attributes from heavy loading on the bridge.

If the bridge was analysed before altering the timber deck to a concrete deck, this tensile stress increase could have been noticed and necessary alterations could have been done. Analysing all bridges in the national road network is not required. Indeed, such a methodology would be costly. However, there are needs to analysis bridges, which seem to carry heavy loads to avoid failures like in the Paragastota bridge.

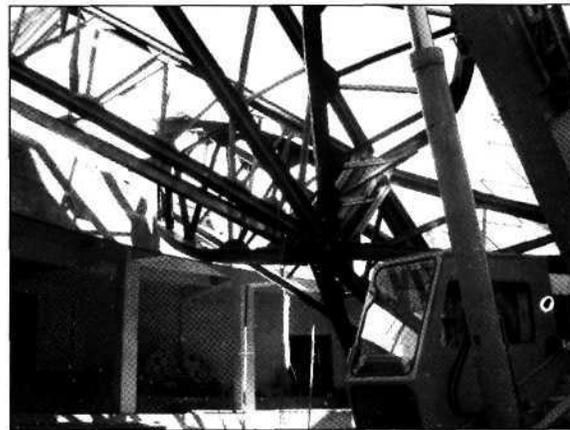
made at the centre to the hub. Afterwards, in order to make the end support connection (to the column), the crane operator had released the belts. While this was being done the belt nearer to the centre had snapped and the collapse occurred, while the outer end of the TR5-2 truss was still in the air, held by the crane.

Figure 6. Collapsed truss system

Investigation into the failure revealed that the Consultant had not given clear instructions to the Contractor regarding the construction procedures, even though the Consultant knew that the Contractor lacked relevant experience. Finite element analysis of the truss system (Figure 6) showed that the truss sub-systems used during the construction phase were not stable, because they were not adequately supported against out of plane buckling. The wobbling of the trusses experienced during construction, and the final failure was due to this. If an experienced engineer was present at the site during construction, he/she would have noticed these. Even though the Consultant had visited the site many times during the roof construction, poor quality of the work had not been reported, and the work had been allowed to continue.

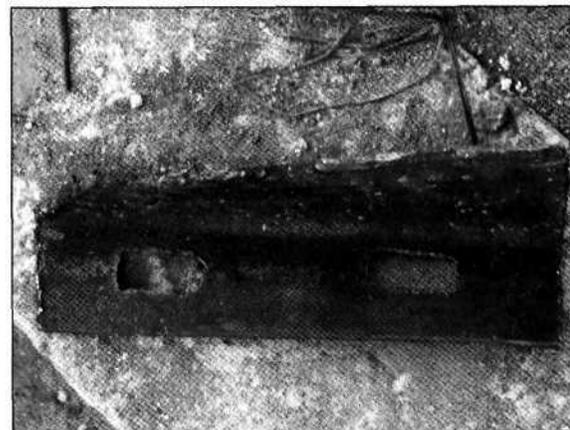
Figure 6 shows the collapsed truss system, and Figures 7 & 8 show some examples of very poor workmanship and violation of specifications, when making connections at supports.

Figure 7. Flame Cut Angle Bracket

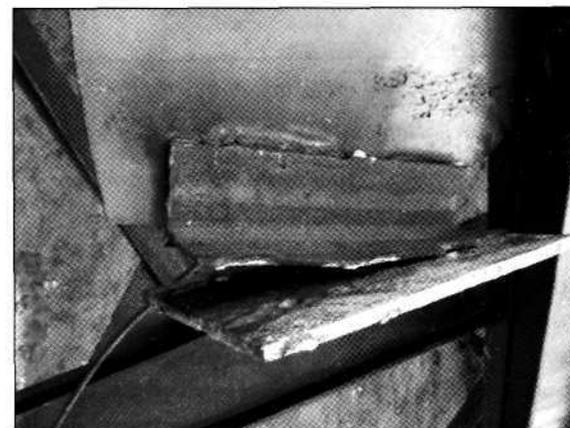
Figure 8. Poor Connection at Shoe Plate

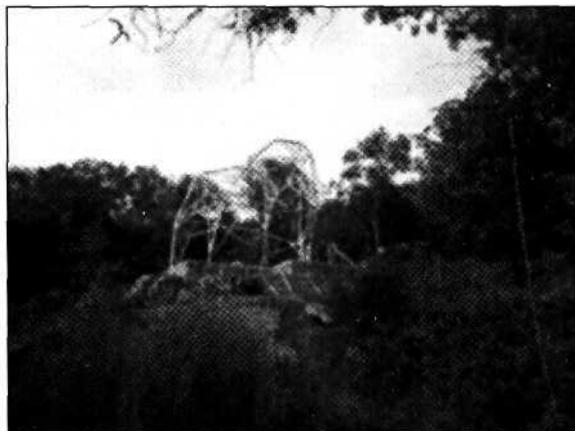
Figure 9: View of the collapsed stage of the tower

angle-iron type. The tower has been designed for steel antenna towers and antenna sporting structures. When it was constructed to a height of 60 m, the tower collapsed suddenly without any warning. Figure 9 shows the collapsed stage of the tower.

1. Compression and tensile forces in members are below the allowable limit of every section for the final design stage as well as for the collapsed stage.
2. At the construction stage, horizontal bracings have not been provided. However, the presence of horizontal bracings is very important since they reduce effective lengths of members and twisting also.
3. Local buckling check was carried out for the collapsed model.
4. All members are satisfied apart from some of the horizontal members.
5. In any connection, if bolts are not properly fixed, it will tend to transfer additional moments to the tower.
6. At the construction stage, the top part (final 10m) of the legs was erected as single angle. Furthermore, there are no bracings at the top part (final 5m). Therefore, the deflections are induced from there.

significant effect on the stability of the structure. In this situation, the Consultant supervised the construction work of the tower. Considering the results obtained, it can be concluded that the design of the tower is safe. With reference to notes 3, 4 and 5 mentioned above, the collapse of the tower occurred as a combination of local buckling behaviour at the construction stage and the conditions mentioned in note 4 and 5.

This failure could have been avoided if the proper construction procedure was given. As with ICTAD guidelines, it is the duty of the Consultant to see the sequences of the construction procedure. As with the general agreement of engineers, how sound a design is it will not be useful if the correct sequence of construction is not followed.

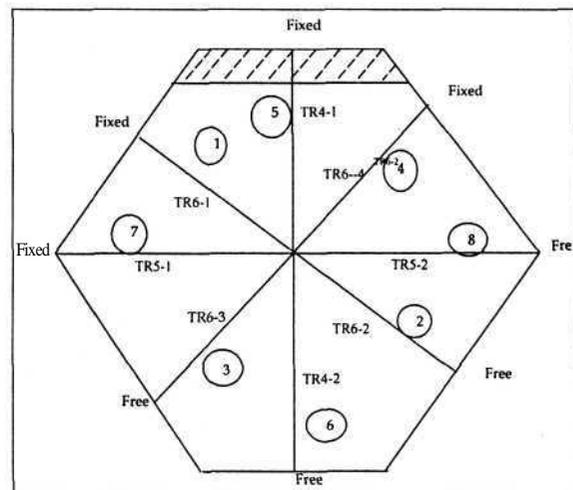
Figure A.1: T Roof Plan Showing Primary Trusses and Construction Sequence

The central part of the roof has a hexagonal plan, and the steel frame which supports it consists of 8 primary trusses supported on concrete columns at their far ends and connected together to a central hub at their common ends as shown in Figure A.1. page 12 In this Figure, circles and numbers inside indicate the construction sequence of trusses.

The Steps a to d above were completed within 2 days and the four TR6 trusses were left standing for almost a month before the Steps e & f were completed (within 2 days). Two days after Steps f and g were attempted, the failure occurred.
