Criteria to Assess Rock Quarry Slope Stability and Design in Landslide Vulnerable Areas of Sri Lanka: A Case Study at Thalathu Oya Rock Quarry

M. N. C. Samarawickrama , U. B. Amarasinghe and K. N. Bandara

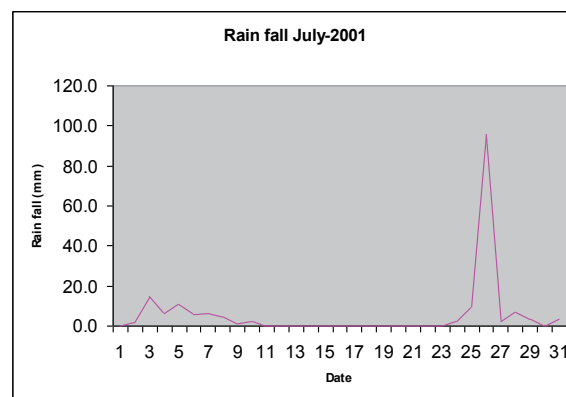
Figure 4 - Rainfall in July 2001 to ThalathuOya

The rainfall data for the particular area pertaining to the time of failure (i.e. July 2001) is plotted in Figure 4. As the rain fall graph depicts, area has received 95mm rapid precipitation on 26th July 2001. This may have caused the sudden increase of pore water pressure on the slip surface of the site, which

ultimately caused to initiate the failure as a debris flow on 28th July 2001 (according to the information given by the neighbors).

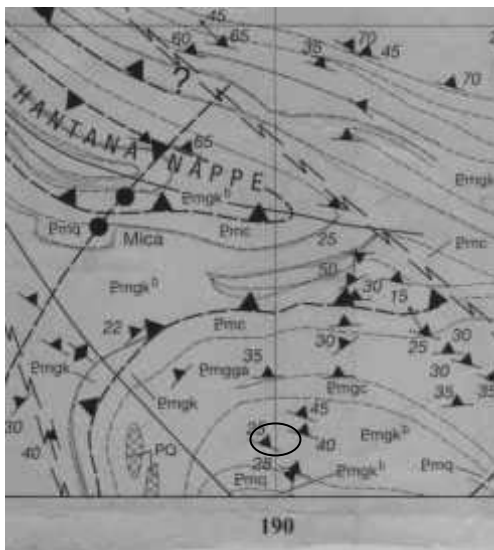
Figure 5 - Structural Geology of the area

When considering the site geological setting, the area belongs to the Highland Series of metamorphic rocks in the central part of the Sri Lanka. Furthermore the structural geology map of the area in Figure 5 reveals that, there is a shear zone running at the North-Eastern boundary of the site. This may be the initiation of the disturbance in the rock mass, which later act as the ground water seepage zone through the rock slope, along a weaker plane of foliation planes, which ultimately act as the slip surface. This can further be justified by the degree of weathering of the rock. The upper and lower parts of this seepage zone is weathered to a lesser degree than the seepage zone, whilst the mid slip surface is excessively weathered and the surface minerals leached due to this same ground water movement. Moreover, chert particles detected from mobilized debris as wells as thin crustal formations at the bottom of the right hand relief surface is good indication of groundwater movement for very longer period, where chert is formed by the

precipitation of silica under hydrostatic pressure for longer periods.

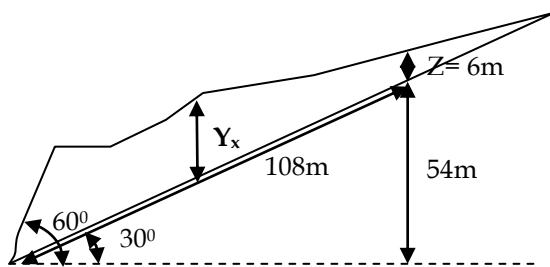
Figure 6 - Approximate Geometry of failed slope

Approximate geometrical parameters of failed slope were obtained from existing relief faces. The overburden thickness (Y_x) varies from 4.50m to 6.50m. The location of probable tension crack was detected at the upper crest of the slope, where it can be traced from remaining extensions in the two relief wedges. The depth of the tension crack was around 6.00m.

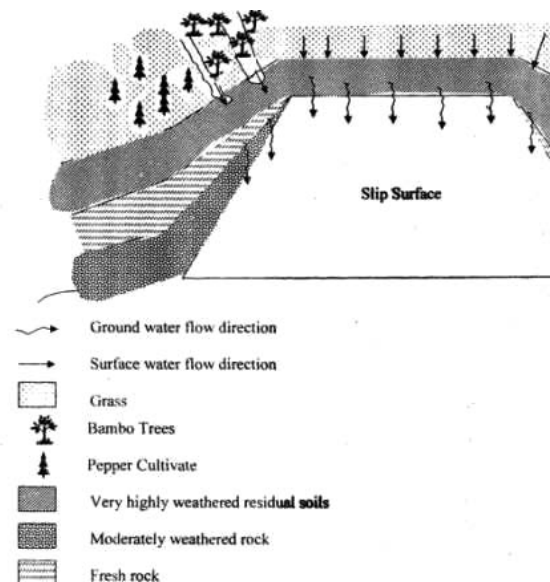
Figure 7 - Hydrogeological setting of the site

The ground water movement in the particular site is shown in Figure 7 and as it depicts, large volume of ground water as well as surface water is passed through the site in the rainy season. There is a catchment area of around fifteen acres which elevates to more than 40m from the crest of the slope. The existence of Bamboo trees in the upper and upper left side parts of the slope crest is a good indication to prove the shallow ground water existence throughout the year. Also existence of surface water draining canals pointing towards the site location is a good indication for water stagnation effect in the rainy season, which ultimately may have caused to increase the pore water pressure conveniently. As mentioned in section 3.3, this process was in existence for very longer period until the ultimate failure.

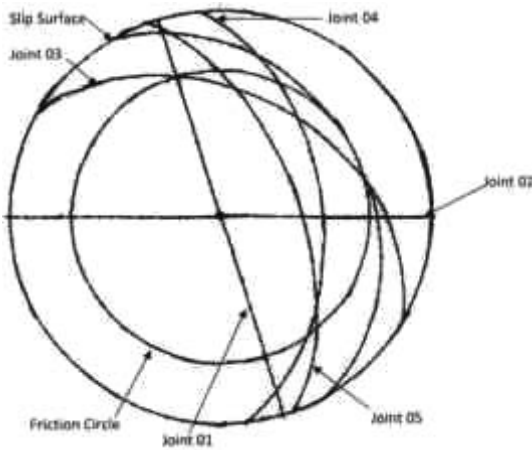
Figure 8 - Stereonet plot of great circles of rock discontinuities

The stereonet plot as shown in Figure 8 was developed based on data in Table 1 and the back analysis results of section 4.1, which was used to plot the friction circle. When considering the kinematic conditions of the possible rock slope failures, it is clear that vertical joint sets 1 and 2 may have contributed to form possible tension cracks due to toppling movements. Individual plane failures are possible for joints 2, 3, 4, 5 and slip surface. Out

of them, most vulnerable is joint 5 and least is along slip surface, which has the least dip. Wedge failures are possible along the combination of joint sets 2&4, 2&5, 3&4, 3&5 and 4&5. From kinematic point of view the most vulnerable of them is the wedging along the intersection of joints 2&5.

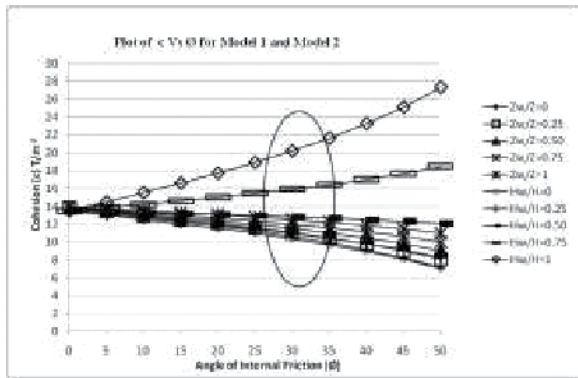
Figure 9 - Cohesion Vs Angle of Internal friction for both failure Models

Equations 1 and 7 in section 2.4.1 were rearranged by keeping the factor of safety (F) equals to unity (which is at limit equilibrium) and range of values were given to “ ϕ ” in order to obtain the variation of “ c ” for two basic slope geometries, which depicts in Figure 9. Previous experimental studies have shown that “ ϕ ” for gneissic rocks is ranged between 27° and 34° [8]. This range is highlighted from the ellipse in Figure 9, from which, the mid value of the range for “ ϕ ”, which is 30° was taken as the angle of internal friction of the slip surface and the corresponding lowest possible value for “ c ” from the curves become 10.35T/m² or 0.1035MPa.

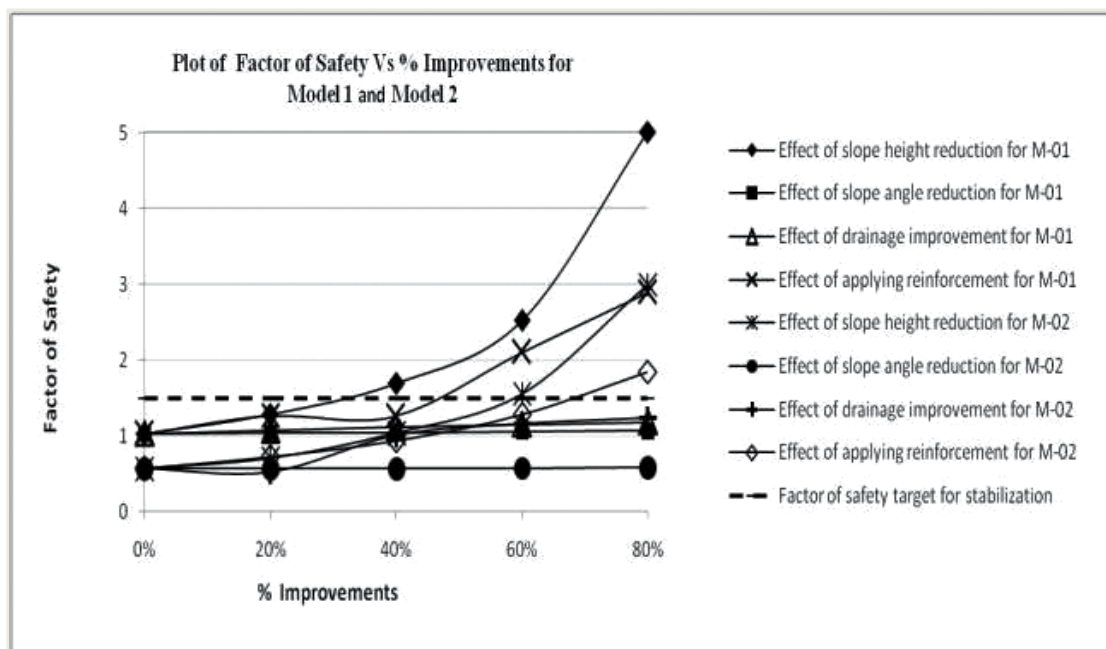
Figure 10 - Variation of Factor of Safety with Percentage improvement for both Failure Models

The required factor of safety was calculated by assuming the worst possible conditions, i.e. when the pore water pressure is at maximum for both of the assumed failure models (Model 01 and Model 02). The shear strength parameters deduced from back analysis were used in conjunction with Equation 1 and Equation 7 in calculating the respective safety factors and plotted the gained factor of safety against percentage improvement by the respective stabilizing technique. It is evident in Figure 10, that the required factor of safety, 1.5 (which is highlighted by the dotted line) can only be achieved through reduction of slope height and the introduction of reinforcements. Out of these two, the most rapid (most economical) and practical method could be the reduction of slope height, as tension bolts will need to penetrate to greater depths than in normal circumstances, since the underlying bedrock is weathered down to a substantial depth. The reason behind lack of effectiveness in reduction of slope angle and drainage improvement can be explained through Figure 6, where slope geometry suggests that reduction of slope angle will reduce the overburden weight in very low proportions as the natural slope surface is running almost parallel to the slip surface after an initial slope angle of 60° .
