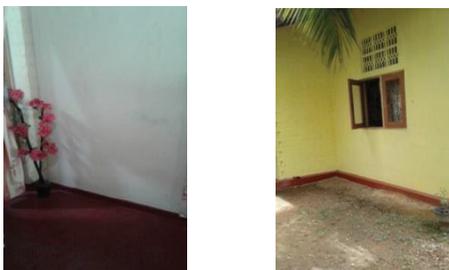
Figure 2 - Surface Coating and Painting

It was found that in all inspected housing units occupants had applied either lime wash or emulsion paint on the surface of the walls, especially inside the houses. Users said that when they touch walls, earth marks remained in their hands, sometimes on their body or cloth. Donor has taken action at initial stages to plaster walls in a few houses because of the requests from users.

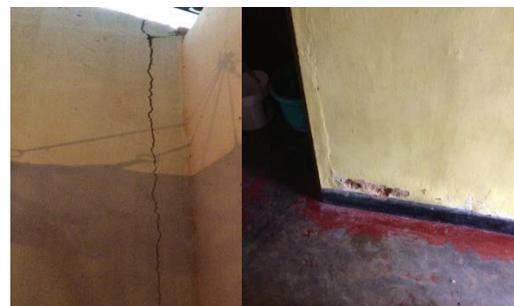
Figure 3 - Defects in CSRE Walls

Defects	Housing unit No.	No. of Houses
Separation cracks (1 to 3 m length) at CSEB wall junctions	16, 15, 14, 28	04
Separation of wall plaster	01, 02,	02
Soil erosion at the base of the walls	01, 02, 16, 15	04
Water born soil erosion	15, 16	02

(a) Separation crack (b) Soil erosion

- iii. CSRE wall junctions can be included along with proper supervision for the construction of CSRE walls to avoid separation cracks at wall junctions in future constructions.

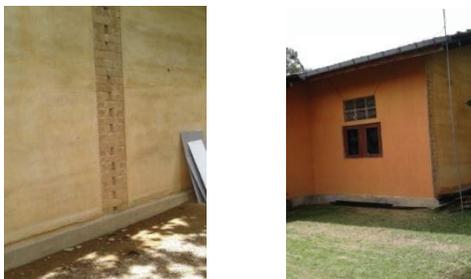
**Figure 5 - Sample Houses**

Since No. 15 and 16 houses have wall separation cracks they are not satisfied with CSRE walls. They think that these walls have low durability than other walling materials. They have experience in its deterioration and highly criticized quality of construction. They mentioned that these walls may have high strength but the failure is due to poor method of construction. Users in houses No. 33, 34 and 35 happily said that they received sample houses and there are no defects.

- v. Three sample houses constructed under proper supervision are in good condition without any defects for 13 year and the occupants are still satisfied about the construction. Therefore CSRE wall technology needs high supervision at construction stage to keep its durability, strength, and especially to be acceptable to the users.

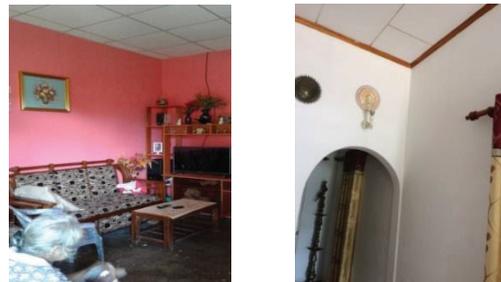
**Figure 6 - Modified Houses**

House modified by the users by adding one or more compartments using cement block masonry walls, applying surface coatings, plastering walls, painting, fixing ceilings and laying floor tiles and wall tiles in kitchen and bath areas.
