A Consequence of Failure of Mid Span Compression Joint on the Kelanitissa-Kolonnawa Line

J. Rohan Lucas and Nanda Munasinghe

Keywords: Overhead line conductor, Straight-through compression joint, Conductor failure, Corrosion, Blackout

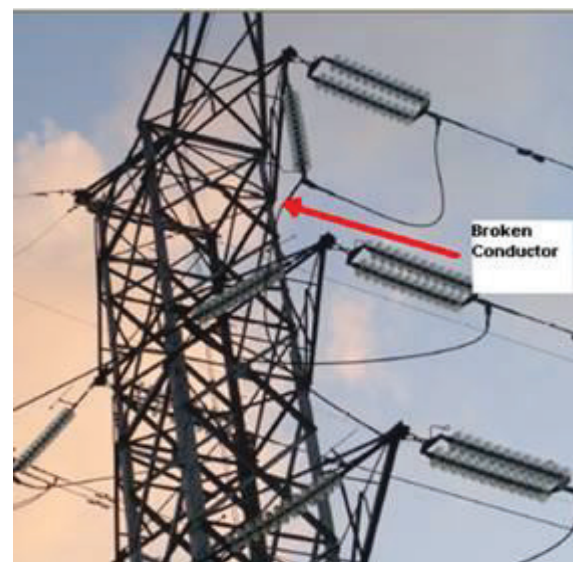
Figure 1 - Location of the Conductor Failure Showing the Failed/Ruptured Conductor [1]

Investigations reveal that in the early hours of the morning, the R-phase conductor of a KEL-KOL circuit fell on the ground, inside the Kelanitissa substation [1]. The R-phase conductor had sheared at the edge of a straight-through joint that existed in the section between the terminal tower and the line gantry at the KEL end. This resulted in breaking the R-phase conductor in mid span into two parts, with one part falling on the ground creating an earth fault.

Photograph has been taken when the tower-side section of the broken R-phase conductor still remained entangled with the tower, touching the Y and B conductors as well.

The other part of the R-phase conductor, still hanging on the insulators attached to the terminal tower, had got entangled with the crossarms of the terminal tower, simultaneously touching the other two conductors (Y and B phases) of the same circuit (Figure 1).

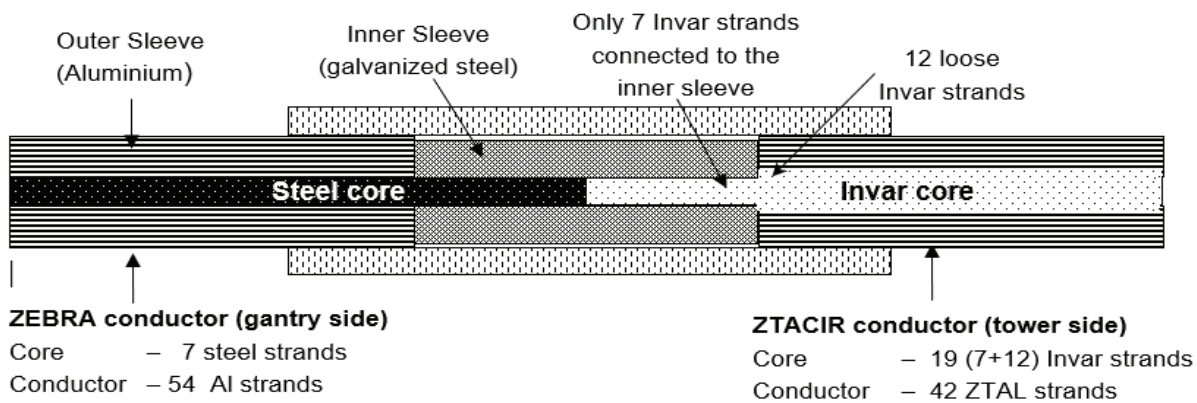
Figure 2 - Schematic Diagram of Failed Mid Span Compression Joint [1]

The ZEBRA jointing sleeves do not fully fit the ZTACIR conductor and has left 12 out of the 19 core strands outside the inner sleeve of the joint during jointing (Figure 2).

Further, owing to inappropriate sleeves, severe arcing has caused the ZTACIR conductor strands to evaporate, until the joint finally failed on 9th October 2009. Severe corrosion was subsequently observed around the failed joint and its sleeves.

Mid-span compression joints between different conductors should only be done with utmost care, and only using the appropriate tools and accessories [5]. In an exigency, in the absence of

fully appropriate accessories, joints made should be only a temporary measure with regular checks being made until rectification as soon as possible.

It is to be noted that material and mechanical properties of the sleeve as well as conductors should be compatible with each other, and the crimping tool should match with the joints and the conductors involved.

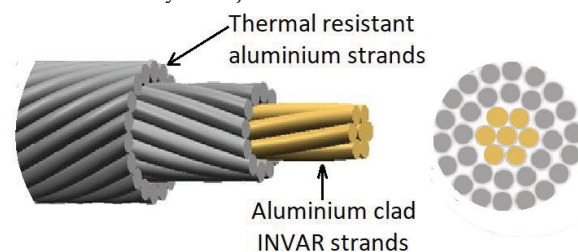
Figure 3 - Structure of ZTACIR Conductor [2]

The conductor on the KEL-KOL line is of type 'ZTACIR' with an inner 'Invar' core (with 19 strands) and two outer layers of conducting strands of thermally resistant aluminium with Zirconium 'ZTAL' (with 42 strands) - stranding details observed from undamaged section of ZTACIR conductor. ZTACIR is especially used to reduce the sag in transmission lines when a higher current carrying capacity is required [2]. The joint that failed was a straight-through joint (Figure 2) between ZEBRA (Steel reinforced

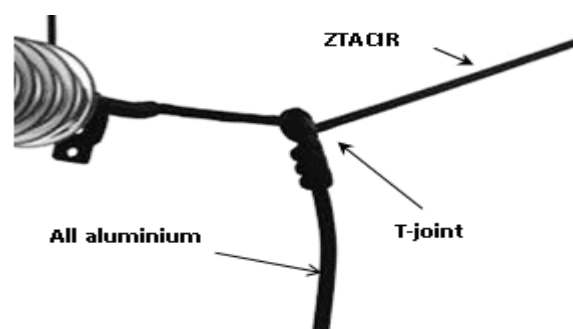
Figure 4 - A T-Joint Similar to the one that was Mechanically Stressed [1]

Earlier, in 2006, a T-joint to tap the ZTACIR down conductor of the R-phase of circuit No. 2 of the transmission line, ruptured. The T-joint taps the down conductor (Figure 4), and serves power to an all-aluminium conductor, which is connected to the switchyard.

Investigations revealed that the T-joint used between 2004-2006 on the ZTACIR conductor was a T-joint normally used for ZEBRA conductors [3]. This ad-hoc measure had been required because no special ZTACIR T-joint spares were available, although this was a line newly built in 2004. It was noted that frequent tightening of the T-joint was required once in a few months, and hot spots were frequently detected on the T-joints. Similar T-joints were fixed in all the other five conductors on this line, and they have been in service throughout 2004 to date, but with constant care by maintenance staff. In addition, owing to the short distance between the tower (where the three conductors are in a vertical plane) and the gantry (where the conductors are in a horizontal plane), higher mechanical stress would have developed in the conductor. This is because of the sharp angle between the main conductor and down dropper at the gantry as seen from Figure 6. The terminal tower is partly visible on the right-hand side. R-phase is the closest to be seen in the picture. The conductor rising from the gantry to the tower snapped and fell on the ground.

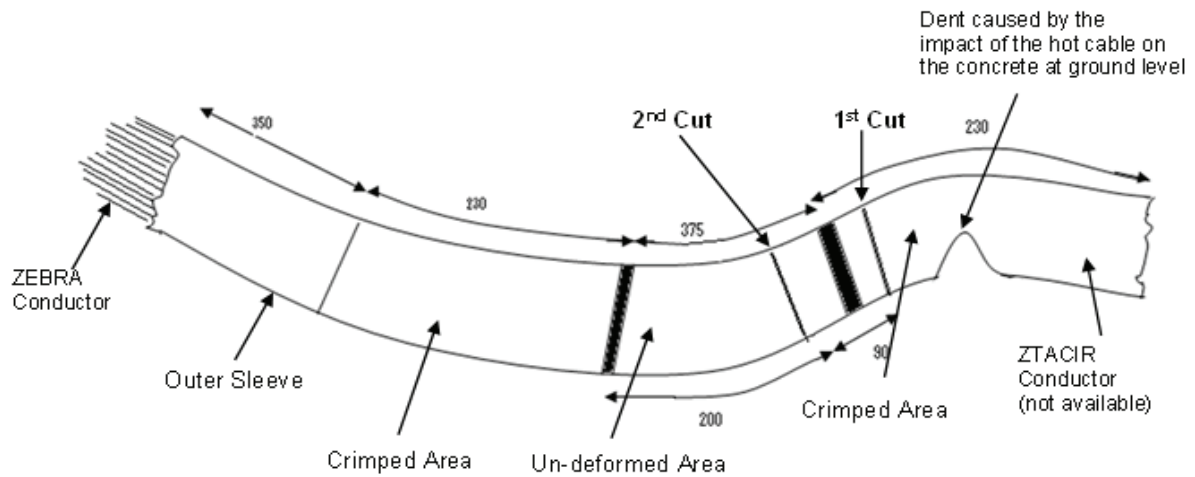
Figure 5 - Damaged Mid-Span Compression Joint made Available to the Study Team [1]

The main part of the damaged mid-span conductor joint available for the study team, is illustrated diagrammatically in Figure 5. A ZEBRA conductor (on the left-hand side) has been connected to the ZTACIR conductor (on the right-hand side) with a steel inner sleeve and an aluminium outer sleeve.

Figure 5 shows sectioning at two locations (1st cut and 2nd cut) to examine the condition of the joint. The entry of the undamaged ZEBRA conductor to the mid-span joint is on the left-hand side, while on the right hand side, where the ZTACIR conductor was fixed, the whole

conductor has been completely burnt and the strands have become detached from the outer sleeve. However, some burnt conductor parts were found stuck inside the outer sleeve.

This is the last segment of the line at KEL end. The ZEBRA conductor was hanging from the insulator string on the gantry, and the section shown in this diagram hit a concrete structure at ground level. Severe ground fault current would have flown in the section during the 3-second period. The cuts were made by the team during investigations.

The conductor was cut initially in the crimped area (see the position of the 1st cut in Figure 5) and it was found that the core strands were separated from the inner sleeve and also the ZTAL strands of the ZTACIR conductor were removed from that area. No conductor strands were observed between inner and outer sleeves. The damaged mid-span joint was further cut (see the 2nd cut shown in Figure 5) and a part of the inner sleeve was taken out from the outer sleeve, where it was found that the inner core wires from the ZTACIR conductor were detached and the fracture surface was indicating some corrosion.

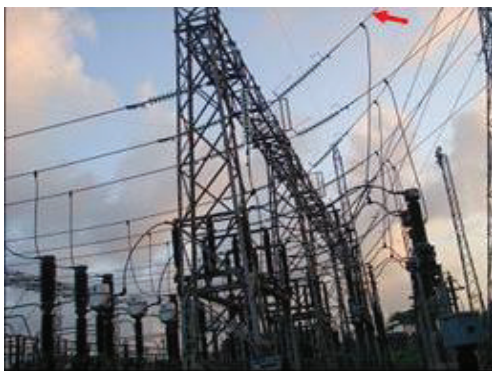
Figure 6 - Conductor Arrangement (Tower to Gantry) of KEL-KOL Lines [1]

Further, the T-joint designed to tap a horizontal conductor was now being used on a conductor with a sharp incline. It would have collected water from the top end owing to the high slope of the conductor from the terminal tower to the gantry. This would have probably led to the increased level of corrosion visible in the sample and is a possible reason for the fracture of the conductor at the T-joint in 2006. As a remedial measure, a section of the ZTACIR conductor between the gantry and the terminal tower was replaced with a ZEBRA conductor. This ZEBRA conductor had been connected to the ZTACIR conductor with a mid-span compression joint.

Owing to the non-availability of the correct material and tools to make a mid-span joint connecting the ZTACIR conductor on the line-side with the Zebra conductor on the gantry-side, jointing material designed for the ZEBRA conductor had been used. After being in operation for approximately three years, this mid-span joint failed on 9th October 2009 and dropped to the ground, leading to the grid failure.

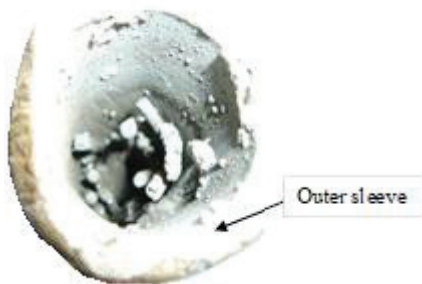
Figure 7 - Burnt Strands in the Outer Sleeve on the TACIR Conductor Fixing Side [1]

The strands had melted and some spatter was also observed on the inner surface of the outer sleeve, as seen in Figure 7.

This indicates a very high increase of the temperature, possibly due to high contact resistance between the conductor strands and the outer sleeve.

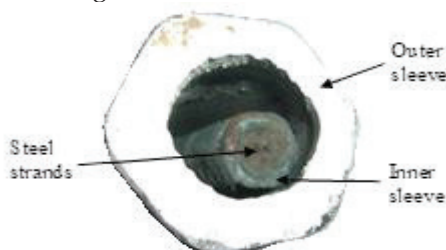
Figure 8 - Inner Sleeve Observed at 1st Cut from ZTACIR Conductor Side [1]

It was also observed that only 7 strands of the 19 strand Invar core of the ZTACIR conductor were fixed inside the inner sleeve. This is because the joint had been made with sleeves meant for the Zebra conductor, in which the inner steel sleeve can accept only the 7 steel strands of the ZEBRA conductor (Figure 8).

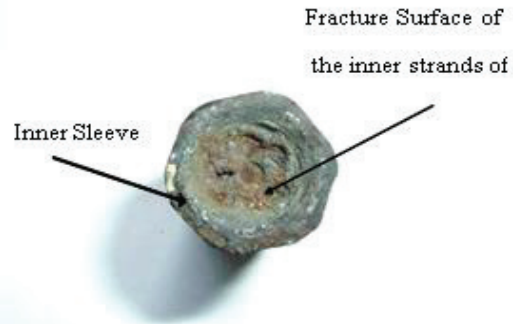
Figure 9 - Fracture Surface of the Steel Strands of the Inner Sleeve, at the 1st Cut [1]

The balance 12 Invar strands of the ZTACIR conductor were free and only fixed by the outer sleeve. This may have caused a premature fracture of the core and caused the detachment of the current carrying aluminium strands from

the outer sleeve. In this process, severe sparks may have been created and temperature would have increased to a level adequate to melt the aluminium strands. The fracture between the 7 Invar strands and the inner sleeve might have been accelerated by severe corrosion of the inner sleeve and mechanical stresses [4].
