# Factors Influencing the Service Life of Buildings

W.P.S. Dias

**Abstract:** The service life of a building depends mainly on its chief structural materials and the environment it is placed in. This paper collates the evidence from condition surveys conducted on some buildings with ages of up to 125 years set in a humid tropical environment, and seeks to arrive at some generalizations. Load bearing masonry walls and timber floors had performed well, as had exposed steel sections that were well maintained. Buildings with such elements could be expected to last well beyond the 'normal' design life of 60 years. If a reinforced concrete building had been exposed to a chloride source, major repairs were required after just half this design life. Carbonation depth was found to broadly obey a correlation with the square root of time. However, it is shown that both depths of carbonation and surface chloride levels can vary considerably in different parts of the same building. These findings have direct implications for both construction (in the choice of materials) and inspection (with respect to sampling and use of multiple test methods).

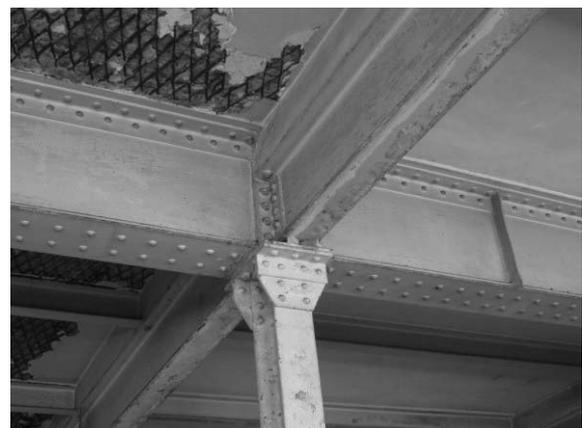
Figure 1 - Exposed steel columns and beams in the 125 year old Gaffoor Building

In the last category are buildings that have survived for 65 to 125 years. It should be noted that the main structural elements are not of reinforced concrete in these buildings; note that these have been constructed prior to the year 1945, alluded to before. Two of the 100 year old buildings had masonry loadbearing walls and timber floors too - i.e. no steel at all. This combination is arguably the best combination for ensuring long service life. The rest of the buildings in this category are steel framed, with reinforced concrete floors or roofs. In almost all cases the reinforced concrete elements experienced significant corrosion, especially roofs and toilet areas. The Grand Hotel displayed only minimal deterioration in the slabs above the kitchens, which are moist and humid environments. In general hotel buildings tend to be well maintained, with defects attended to promptly. Steel columns and beams that were exposed (and hence easily painted) performed very well, as seen in the 125 year old Gaffoor Building (Figure 1), where the contrast with the reinforced concrete slab is stark. On the other hand, encasing the columns in concrete (Figure 2) and the beams in a mesh and plaster covering (Figure 3) resulted in undetected corrosion of the structural elements.

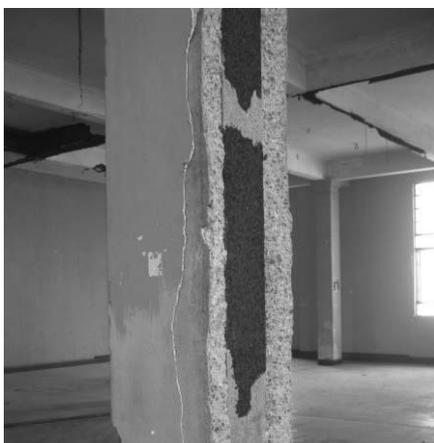
**Figure 2 - Significant corrosion in concrete encased steel internal column in Central Point building**

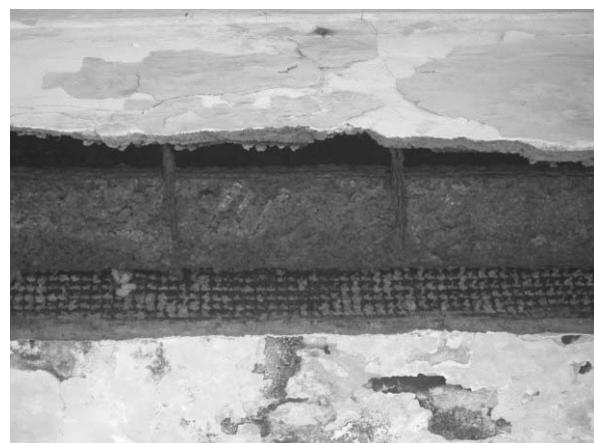
**Figure 3 - Corrosion in steel floor beam covered by wire mesh and plaster in Central Point building**

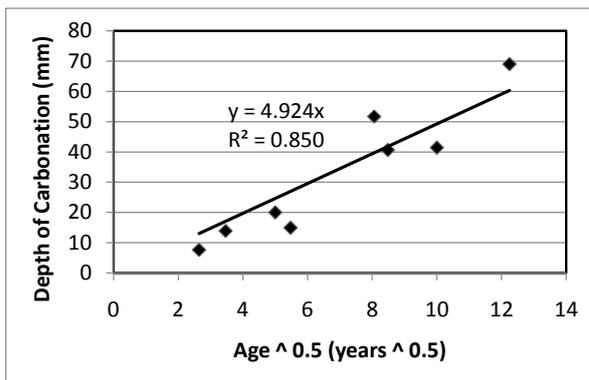
will be lost, and corrosion will take place, especially in a moist or wet environment. The depth of carbonation is considered to be a function of the square root of time. Figure 4 gives a relationship for these two entities (the trend line is not forced through the origin) for some of the buildings in Table 1 together with a few others. Such a universal relationship will not strictly be possible for concretes of various qualities, and even moisture conditions. However, since most of the concretes are of around grade 20 quality, Figure 4 could be used to obtain approximately the likely carbonation depths in concretes of various ages.

**Figure 4 - Carbonation depth as a function of the square root of time**

The slope of a logarithmic plot between depth of carbonation ( $d$ ) and time ( $t$ ) will give an estimate of the exponent 'n', in the relationship  $d = k(t)^n$ , where  $k$  is a constant. Such a plot in Figure 5 gives the exponent as 0.69, somewhat higher than the usually adopted value of 0.5 (i.e. the square root of time law). This may be due to the possibility that the older concretes have a higher  $k$  value than the more recent ones (Richardson, 1988). A plot using only the first four data points in Figure 5 (corresponding to a maximum age of 30 years and years of construction from 1958 to 1991) gives the expected slope of 0.52. It should be noted that these four data points all fall below the regression line in Figure 4.

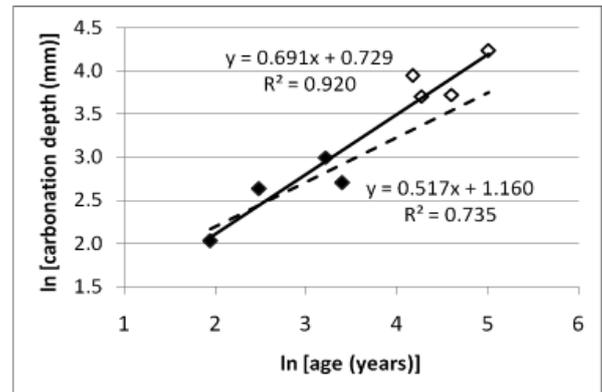
**Figure 5 - Determining the exponent 'n' in the expression  $d = kt^n$**

Figure 5 is based on the average carbonation depths from the buildings surveyed. There can however be significant differences between various areas in a building. For example, Figure 6 shows the differences in depths of carbonation for toilet areas compared to corridor ones in the 30 year old Bandaranaike Wing of the Colombo General Hospital (Dias and Sivasubramaniam, 1989). The corridor areas were more carbonated because the

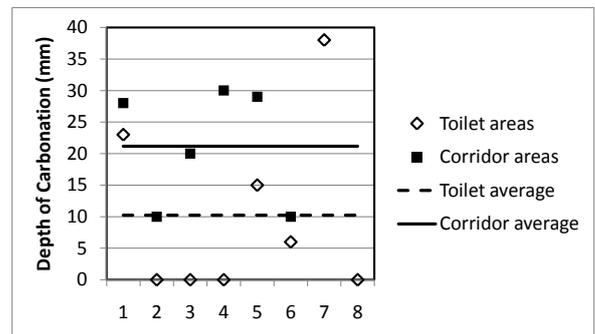
concrete was dry, whereas the toilet areas were less carbonated because the concrete was wet, with 4 zero values too. However, there is greater scatter in the values for the toilets, inclusive of some high values - these regions would be very susceptible to corrosion if the carbonation depth exceeds the cover provided, because of the wet conditions. The phenomena of zero carbonation depths and widespread variation in such depths within a building have been reported before (Roy et al, 1996).

**Figure 6 - Carbonation depths at Bandaranaike Wing, Colombo General Hospital**

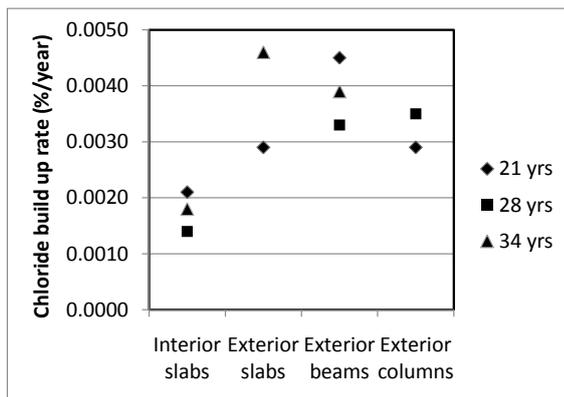
Figure 7 gives the variation in the rate of surface chloride build up for different elements in 3 coastal hotels of varying ages. There is a clear difference between the rates for interior and exterior elements, with the former being significantly less than the latter and displaying much less scatter. It should be noted that these rates have been obtained from the water soluble average chloride contents in plasters of thickness around 10 mm. The published literature for total surface chloride build up rates on concrete surfaces can range from 0.004% to more than 0.1% by weight of concrete

**Figure 7 - Surface chloride build up rates at 3 coastal hotels of different ages**

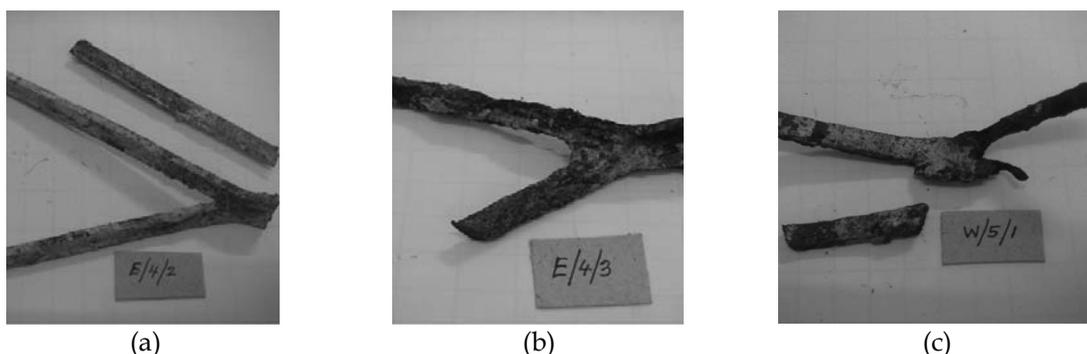
Another example of within structure surface chloride level variations is given in Table 2 for the 100 year old Central Point building in Colombo Fort, a capital port city. These total (i.e. acid soluble) chloride levels were obtained from 5 mm thick slices cut from the bottom surfaces of 4 cores taken at each floor level. The very high levels in the fourth and fifth floors compared to the lower ones may be due to the shielding of the lower floors by surrounding buildings. It may also be due to sea spray contaminated rainwater entering the upper floor levels through observed leaks in the concrete roof. The evidence for the chloride level variation is confirmed by the degree of corrosion observed in the mesh reinforcement embedded in those cores. Figures 8(a), 8(b) and 8(c) give examples of the degree of corrosion defined as low (L), medium (M) and high (H).

**Figure 8 - Degrees of corrosion in embedded reinforcement: (a) Low; (b) Medium; (c) High**

Greater confidence in the sampling can be obtained by combining and comparing different test results. For example, the surface chloride levels can be compared with the degree of corrosion in embedded reinforcement. Comparisons can also be made between the structure being investigated and the accumulated data from buildings in a
