Stakeholder Perception Management of the Crisis at the Samanalawewa Hydro Power Station of Ceylon Electricity Board

A. P. K. Mutunayake

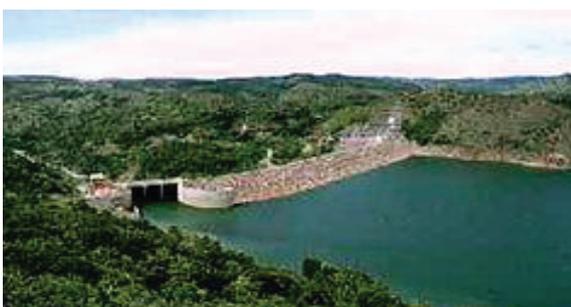
Figure 2 - Samanalawewa dam and reservoir

The Samanalawewa Hydro Power Station (SWPS) which has a 120MW (i.e. 2 x 60 MW) of installed capacity is the fifth largest CEB owned hydro power station. The power station commenced its commercial operations in 1992 after the completion of its construction work under the SHEP Project. The upstream view of the Samanalawewa dam and the reservoir is shown in Figure 2.

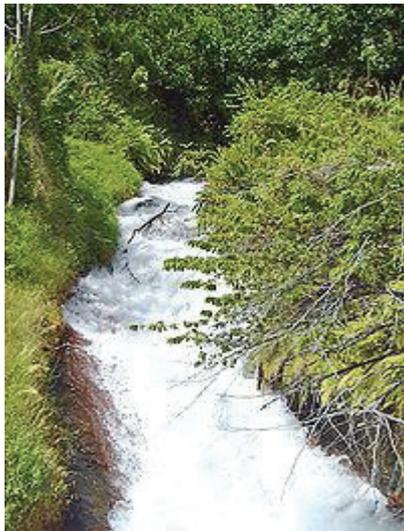
Figure 3 - Samanalawawa Leak

Additionally, up to a distance of 2.5 km on the right bank, a flat water table had been observed responding to the river levels. As a remedial measure, a 100m-deep, 1300m-long grout curtain had been constructed, using 13,640 tons of cement, and impoundment resumed. However the leakage had increased and continued finally resulting in a land slide (Laksiri et al, 2005). Due to the massive water leakage, reservoir impoundment had been again suspended, and more detailed investigations carried out. According to the records, this had been the first such experience of CEB in the history of hydro power generation projects. Figure 3 shows the water leakage of the right bank of the Samanalawewa reservoir.

The next remediation effort consisted of installing a liner of clay over the suspected ingress zones (i.e. wet blanketing). According to Laksiri et al, 2005, even after using 50,000 m³ of clay, the leakage could not be stopped, although it did help to reduce groundwater pressure in the right bank.

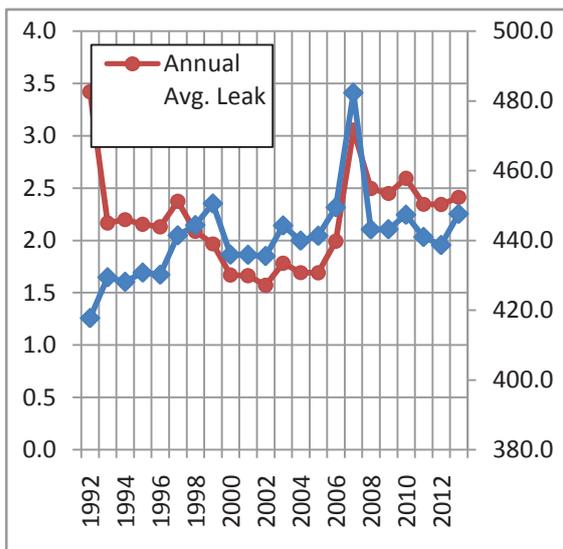
Figure 4- Behaviour of Leak & Reservoir Water Levels (1992-2013)

According to the SWPS dam monitoring data, the reservoir is presently operating with a continuous uncontrolled water leakage of 2.3 to 2.4 m³/s. The behavior of the leak and reservoir water levels is shown in Figure 4.

Source: Author prepared from Samanalawewa Dam Monitoring Data (1992-2013) -CEB

around 1.5 to 2 m³/s depending on the reservoir water level. After the 2nd blast of the leak in 2006 it is now operating at an average rate of 2.4 m³/s.

However, on December 3, 2006 (2nd blast), the amount of water leakage surged to over 5m³/s. After that, as the groundwater level in the right bank and the reservoir water level lowered, the amount of water leakage decreased to 2.9 m³ per second (as of March 12, 2007), which was still higher than the leakage experienced prior to the implementation of the remedial work. Therefore, it can be said that the purpose of the remedial work was fulfilled until December 2006. However, the remedial work is no longer being carried out as intended.
