Forensic Investigation on Design and Construction Failures

P. B. R. Dissanayake

Abstract: In this study, forensic investigations on several structural failures in Sri Lanka have been investigated. The reasons that led to failures of these selected case studies have been studied. In this context, method of forensic investigation includes structural analysis, Finite Element Modelling and material testing to some extent. With the outcomes of those analyses, real reasons for each failure have been explained. Furthermore, the responsibilities of some of the failures in these cases are highlighted. Finally, general conclusions are drawn from the study.

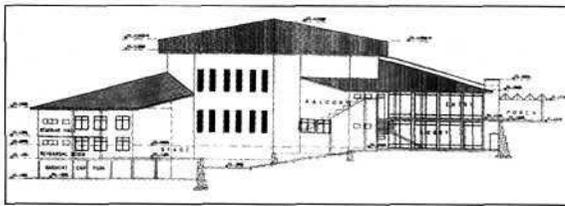
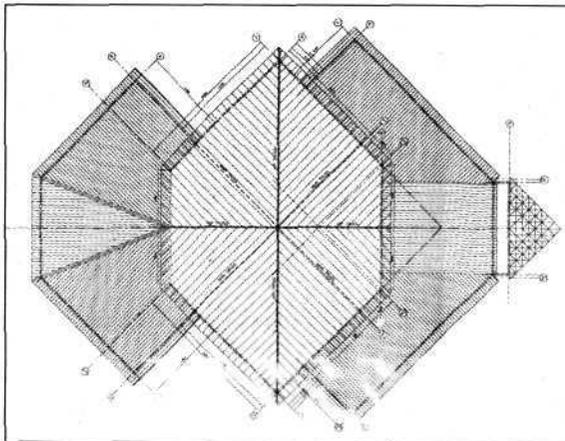
Figure 4. Elevation and plan of the auditorium

This case involves the construction of an auditorium, having a reinforced concrete structure with an asbestos roof, supported on steel trusses forming a dome type frame. Figure 4 shows the elevation and plan of the building.

The central part of the roof has a hexagonal plan, and the steel frame which supports it consists of 8 primary trusses supported on concrete columns at their far ends and connected together to a central hub at their common ends as shown in Figure A.1. page 12 In this Figure, circles and numbers inside indicate the construction sequence of trusses.

These 8 trusses are of three types (Figure A.1). Four main trusses of Type TR6 each of span 15.575 m, two shorter hip trusses of Type TR4 each of span 14 m, and two longer hip trusses of Type TR5 each of span 22.25 m. Several shorter secondary trusses (not shown) are connected to the hip trusses and the roof purlins, supporting the asbestos sheets, are laid on these trusses. A 3D finite element model used to analyze the truss system is shown in Figure 5

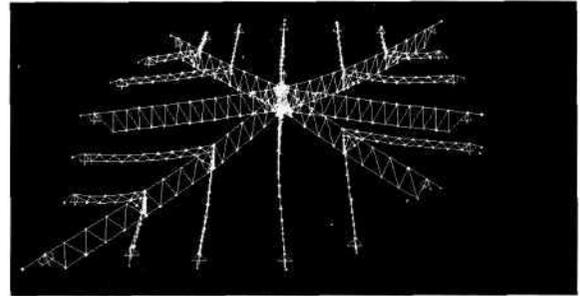
Figure 5. Finite Element Model of the Truss System

The top and bottom chords of the trusses are double channels and the webs are double angles. They are welded to gusset plates except at the central hub, where they are bolted to gusset plates which are welded to the central hub. At their supports on RC column tops (Figure A.1), four trusses are fixed (pinned) with angle cleats welded to gusset plates of the trusses and bolted to rag bolts and placed on a shoe plate at the column top. The other four truss supports are made free (sliding), with slotted holes in the angle cleats, which are free to slide on shoe plates.

Investigation into the failure revealed that the Consultant had not given clear instructions to the Contractor regarding the construction procedures, even though the Consultant knew that the Contractor lacked relevant experience. Finite element analysis of the truss system (Figure 6) showed that the truss sub-systems used during the construction phase were not stable, because they were not adequately supported against out of plane buckling. The wobbling of the trusses experienced during construction, and the final failure was due to this. If an experienced engineer was present at the site during construction, he/she would have noticed these. Even though the Consultant had visited the site many times during the roof construction, poor quality of the work had not been reported, and the work had been allowed to continue.
