Criteria to Assess Rock Quarry Slope Stability and Design in Landslide Vulnerable Areas of Sri Lanka: A Case Study at Thalathu Oya Rock Quarry

M. N. C. Samarawickrama , U. B. Amarasinghe and K. N. Bandara

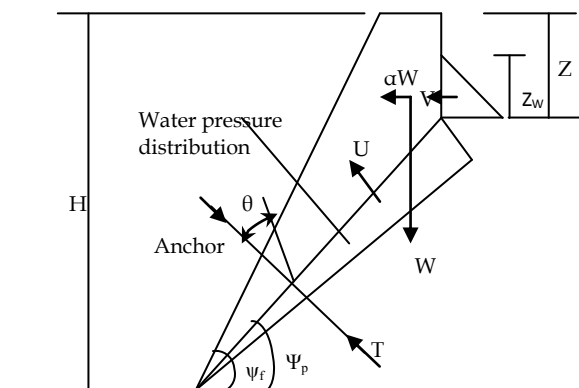
Model-01

Figure 1 - Model 01: with a tension crack

The Figure 1 and Figure 2 and Equations 1 to 10 were used in determining the value range for cohesion. Here, c' and ϕ are the cohesion and angle of internal friction of rock and U - pore water pressure, V -thrust force generated in the tension crack, W - weight of the sliding wedge, α - coefficient seismic acceleration taken as $0.08g = 0.785$, H -slope height, ψ_f - slope face angle, ψ_p - dip of slip plane, z - tension crack depth, Z_w - water head in tension crack in Model 01, H_w -water head in slip plane in Model 02 and T -reinforcement applied through tension bolting (if available).

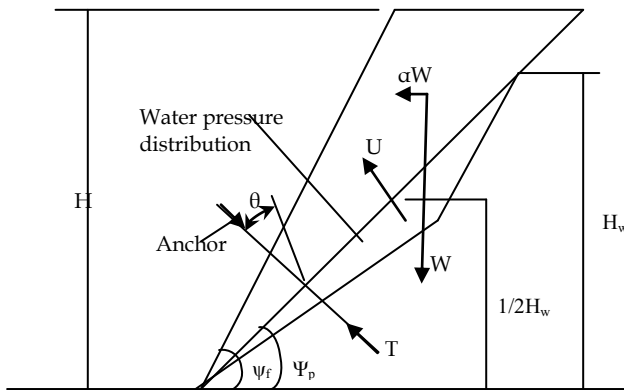
Model-02

Figure 2 - Model 02: without a tension crack

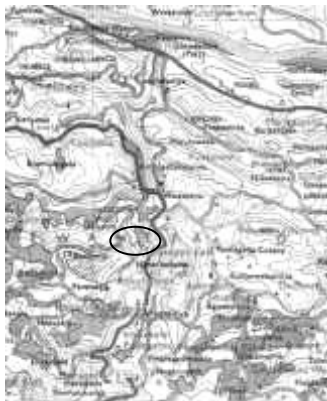
Figure 3 - Topography of the site

The particular site under study is at ThalathuOya in the Patahewaheta Divisional Secretariat of Kandy District, at a distance of two kilometers from ThalathuOya town to the left side of the Moragolla road, at an altitude of approximately 600MSL. The study area where slope failure has occurred extends to about two hectares.
