# Treatment of Seepage through Vendarasankulum Twin Reservoir in Eastern Sri Lanka - Cost Comparison of Alternative Techniques

D. A. R. Dolage, S. P. P. Gamage and T.V.K.I.S. Karunasena

**Abstract:** The purpose of this study is to select a more effective technique from 'upstream cutoff' and 'grouting treatment' for the control of seepage through the Vendarasankulum reservoir. Using engineering judgment, empirical and theoretical knowledge, trapezoidal cross sectional dimensions of layers of different soil materials were determined. For example, the cross section at 490m (from left); SC layer on the U/S side slope has widths, 3m and 12m at bund top and bottom respectively; clay layer in the core has widths 12 m and 3 m at the top and bottom respectively. The effective fetch (1.72 km) and thereby the maximum wave height (0.84m) were computed in order to extract values for thicknesses of riprap (0.45 m) and bedding layer (0.30m). Grouting treatment involves clay-cement grouting in the overburden and 6m deep cement grouting in the rock, requiring a total of 296 grout holes. While the estimated cost of construction of the upstream cutoff is SLR 30.3 million, the same for grouting tre

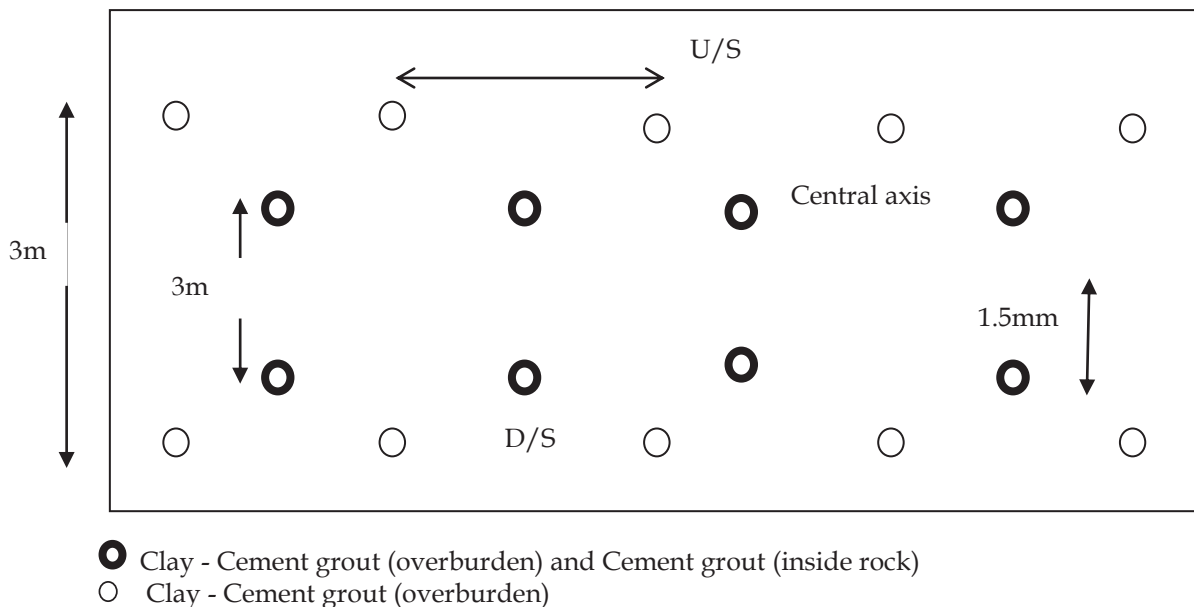
**Figure 2 - Plan view of grout hole arrangement at bund top level**

The seepage problem in the Vendarasankulum reservoir continued to be a major concern of the IDSL calling for solutions. In order to identify the cause for high seepage problem, drilling investigation was carried out towards the end of 2003. Drilling had been carried out between chainages 470 m and 590 m. Eight bore holes have been drilled in the bund, namely BH1 to BH8, and details are depicted in Table 2. The IDSL carried out mitigative grouting work in two stages (as per Figure 2); Stage 1, treatment of overburden; Stage 2, treatment of rocky foundation.

Grouting in the overburden as well as the rocky foundation resumed after a lapse of two months from the completion of Stage 1, in 2007 in the same dam stretch. Thirty six holes were drilled in two parallel lines on the bund top but
